Home Inspection Report

14709 W. Sentinel Dr, Sun City West

Inspection Date:
11 November 2019

Report Number:
19315-1-1

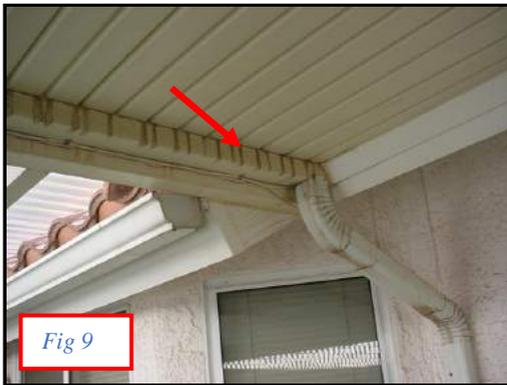
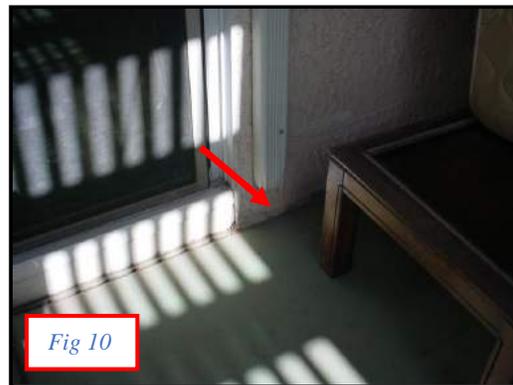
- **Repair:** The downspout(s) should discharge water at least five (5) feet from the house. Storm water should be encouraged to flow away from the building at the point of discharge. *Fig 10, Fig 11*

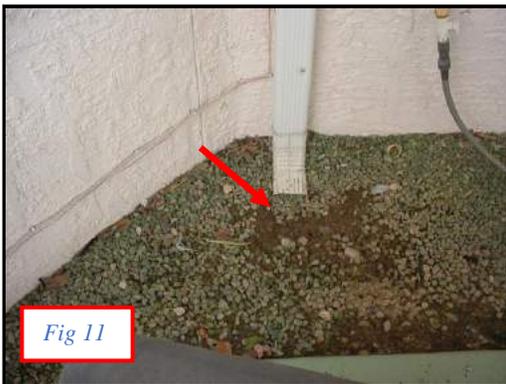
- **Improve:** Birds should not be allowed to nest on the roof. Preventative measures should be taken to eliminate this condition. *Fig 12*
- **Repair:** Active roof leaks were detected above the laundry room. The valley flashing is vulnerable and should be extended to help prevent water from being discharged under the roofing material. Water damage was observed to the ceiling in the laundry room and to the adjacent eave. Further evaluation by a qualified contractor is recommended and repairs should be made as necessary. *Fig 13, Fig 14, Fig 15, Fig 16*

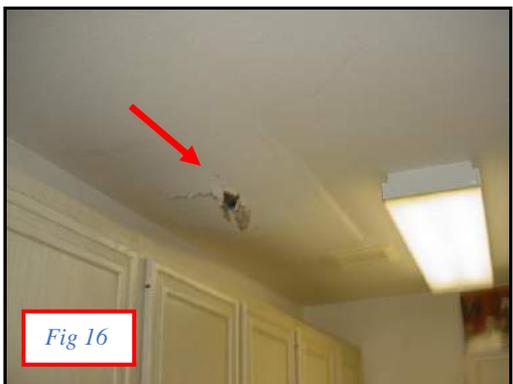
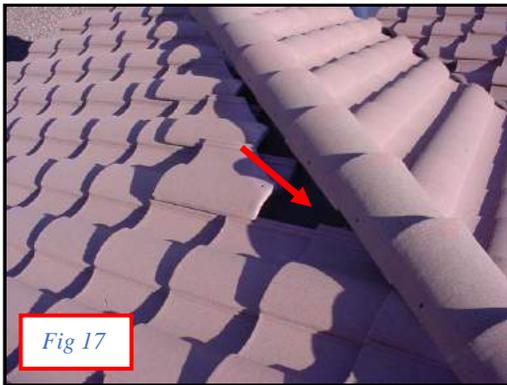
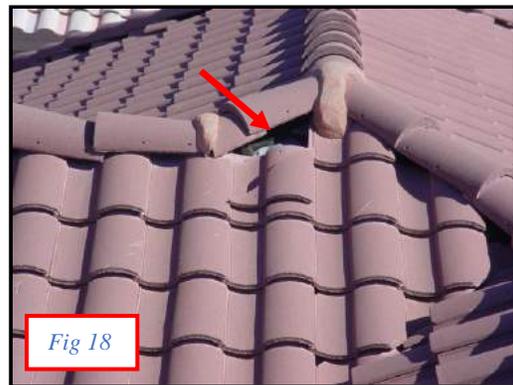
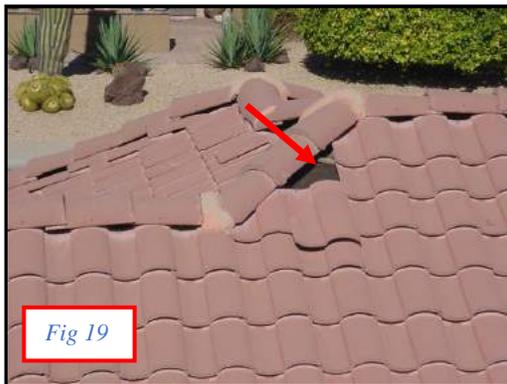
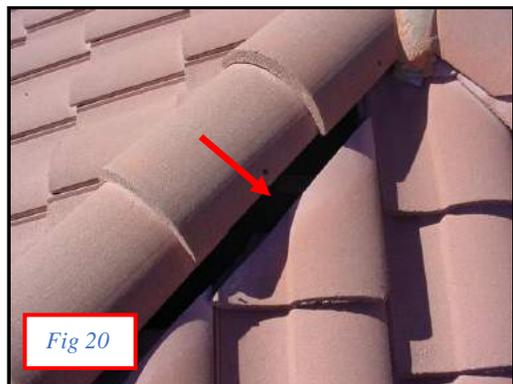
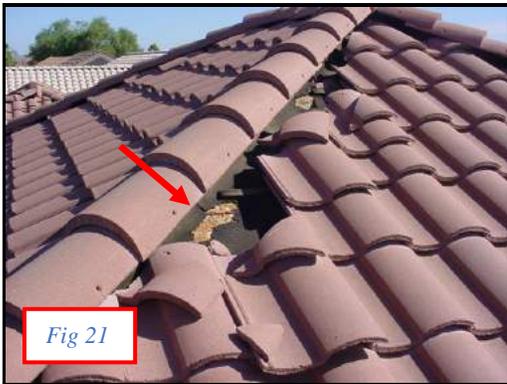
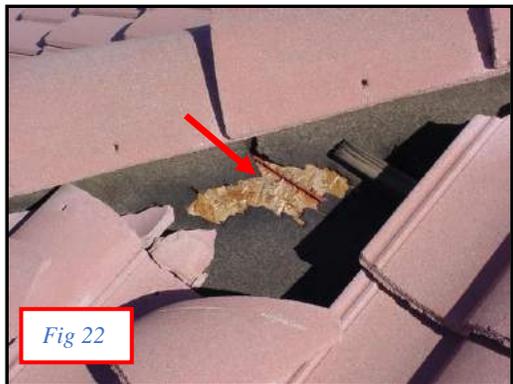
- **Significant Defect, Repair:** Given the age and condition of the roof, the roof has reached the end of its useful life. Exposed felt underlayment and/or sheathing is visible where the roofing is damaged. Damage to the felt underlayment on the roof and evidence of active leakage was observed. Replacement of the entire roof is recommended at this time. Further evaluation by a qualified contractor is recommended and repairs should be made as necessary. *Fig 17, Fig 18, Fig 19, Fig 20, Fig 21, Fig 22, Fig 23*

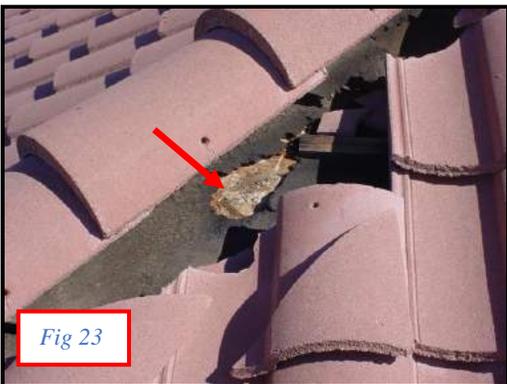
- **Repair:** The exterior stucco finish appears to be loose and separating from the house on the east side of the house. Repairs are highly recommended to help prevent water intrusion and rot to structural components. (See Plumbing Section) *Fig 24*

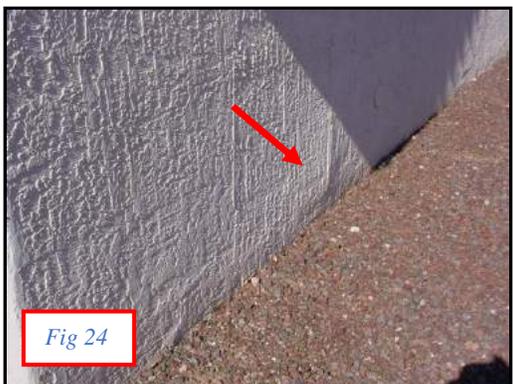
- **Repair:** The soffit and or fascia (the wooden board to which the gutter is typically fastened) should be painted. *Fig 25, Fig 26*
- **Improve:** The grading should be improved to promote the flow of storm water away from the north and east sides of the house. *Fig 27, Fig 28*

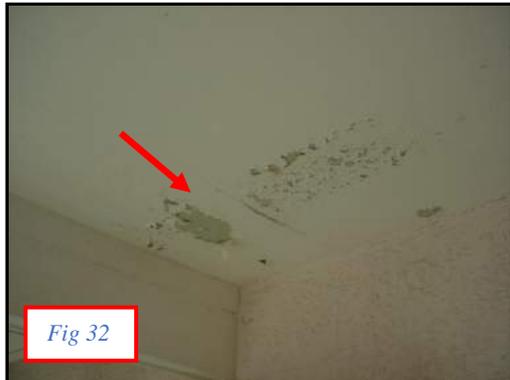
Fig 33

56. **Improve:** The grading should be improved to promote the flow of storm water away from the courtyard. *Fig 33, Fig 34, Page 23*
57. **Improve:** Damaged garage door trim should be properly repaired, caulked and painted as necessary. *Fig 40, Page 23*

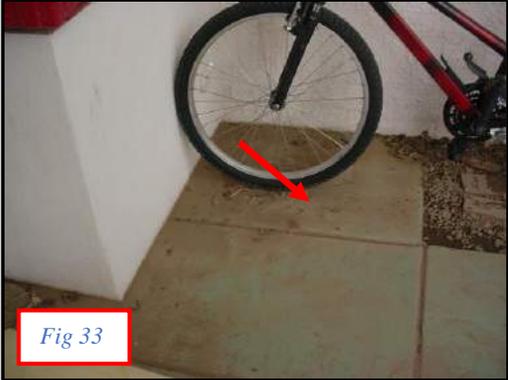
- **Improve:** The grading should be improved to promote the flow of storm water away from the courtyard. *Fig 33, Fig 34*
- **Repair:** Typical minor cracks were noted in the drywall in the garage. *Fig 35, Fig 36, Fig 37*

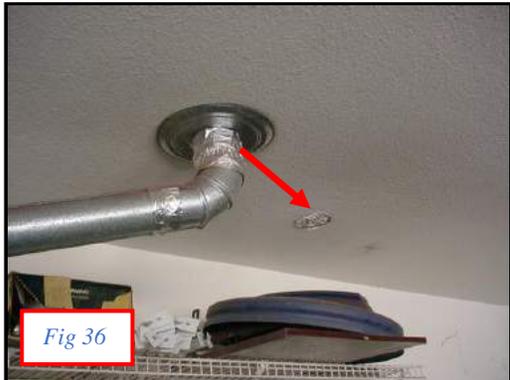
Fig 36

11. **Repair, Monitor:** Ceiling flaws were noted to the front entry ceiling and should be repaired as necessary. [Fig 31, Fig 32, Page 23](#)
12. **Repair:** Typical minor cracks were noted in the drywall in the garage. [Fig 35, Fig 36, Fig 37, Page 23](#)

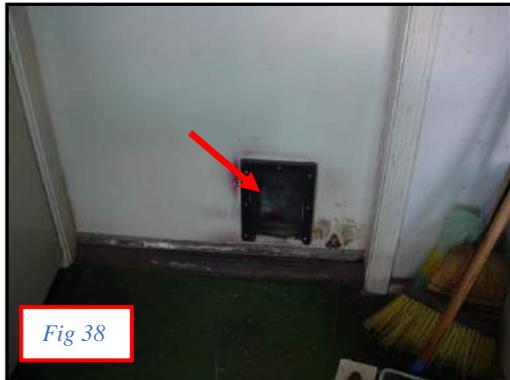
Fig 38

2. **Safety Issue, Repair:** The pet door between the house and garage breaches the fire wall and should be removed. [Fig 38, Page 23](#)
3. **Safety Issue, Repair:** The HVAC ductwork in the garage breaches the fire wall and should be removed. [Page 23](#)

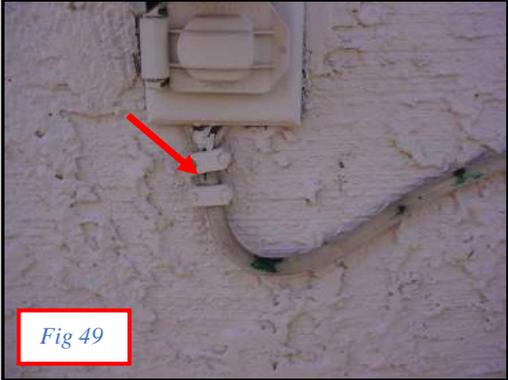
Fig 49

20. **Repair:** Wiring exposed on exterior finishes should be relocated or protected by a rigid conduit. [Fig 49, Fig 50, Fig 51, Fig 52, Page 25](#)

- **Repair:** Wiring exposed on exterior finishes should be relocated or protected by a rigid conduit. [Fig 49, Fig 50, Fig 51, Fig 52](#)
- **Repair:** Oversized breakers within the main electrical service panel should be replaced. Circuits with a wire size of 14 AWG should be sized with a fifteen (15) amp breaker. [Fig 53](#)

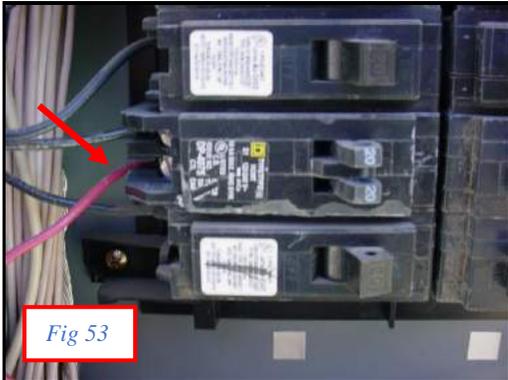
Fig 53

21. **Repair:** Oversized breakers within the main electrical service panel should be replaced. Circuits with a wire size of 14 AWG should be sized with a fifteen (15) amp breaker. *Fig 53, Page 25*

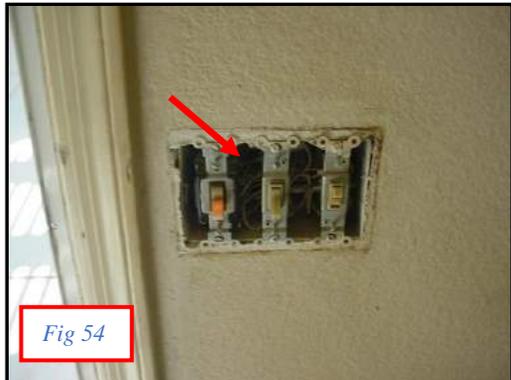
Fig 54

22. **Repair:** Missing light switch cover plates should be replaced to avoid a shock hazard. *Fig 54, Page 25*
23. **Repair:** Ungrounded 3-prong outlets in the casitas should be repaired as necessary. *Fig 55, Page 25*

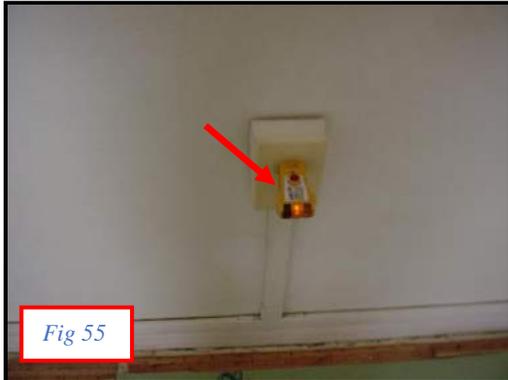
Fig 55

- **Repair:** Missing light switch cover plates should be replaced to avoid a shock hazard. [Fig 54](#)
- **Repair:** Ungrounded 3-prong outlets in the casitas should be repaired as necessary. [Fig 55](#)

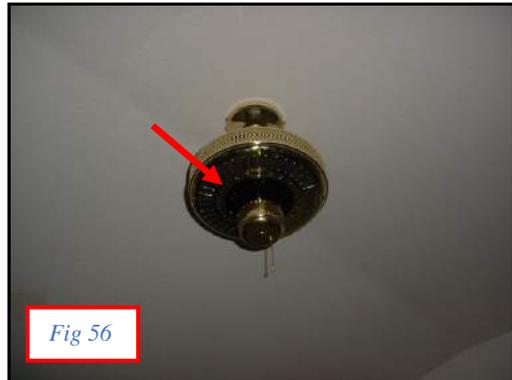
Fig 56

24. **Repair:** Missing blades for the ceiling fan should be replaced in the bedroom. *Fig 56, Page 25*
25. **Repair:** All junction boxes should be fitted with cover plates in order to protect the wire connections. *Fig 57, Page 25*

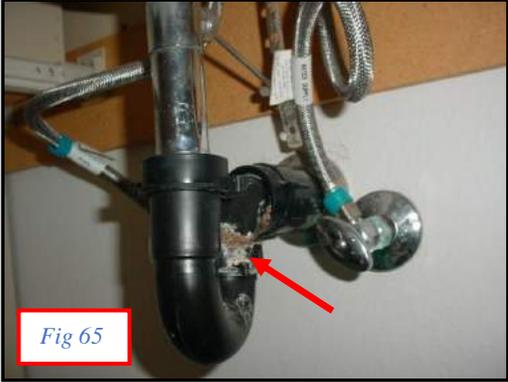
Fig 65

71. **Monitor:** Corrosion on the exterior of the supply and waste piping was observed. *Fig 64, Fig 65, Page 31*
72. **Monitor:** The supply piping shows evidence of corrosion where it meets the water heater. This is a common condition. *Fig 67, Page 31*

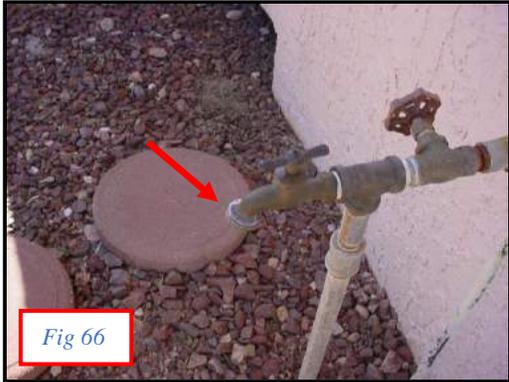
Fig 66

31. **Repair:** To reduce the risk of contamination of supply water, installation of anti-siphon devices on exterior hose bibs would be wise. *Fig 66, Page 31*

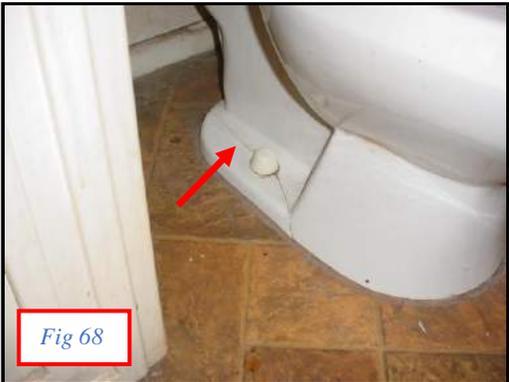
Fig 68

32. **Repair:** The toilet in the casitas bathroom is cracked and should be replaced as necessary. *Fig 68, Page 31*
33. **Repair, Monitor:** Evidence of water damage to the wall adjacent to the bathtub enclosure was observed in the casitas bathroom. This area should be repaired as necessary and closely watched for signs of new activity. Measures should be taken to avoid water damage in this area in the future. *Fig 69, Fig 70, Page 31*

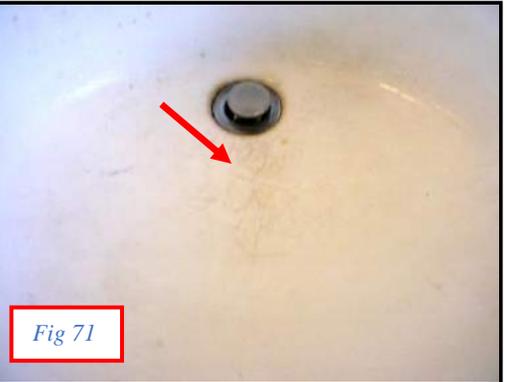
Fig 71

34. **Repair:** The finish to the sink is chipped in the casitas bathroom and should be repaired as necessary. *Fig 71, Page 31*
35. **Repair:** The hall bathroom faucet is leaking and should be repaired or replaced as necessary. *Fig 72, Page 31*

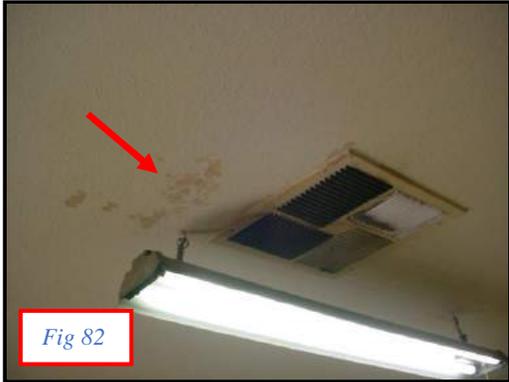
Fig 82

41. **Repair:** The shower door latch in the master bathroom is damaged and should be repaired or replaced as necessary. *Fig 80, Page 31*
42. **Monitor, Repair:** Interior painting improvements are recommended throughout the house. *Fig 82, Page 34*

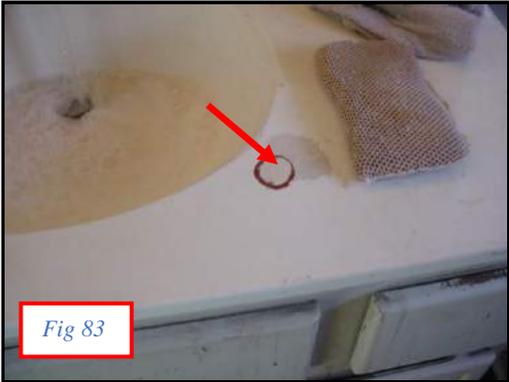
Fig 83

43. **Repair:** The casitas bathroom counter shows evidence of substantial wear. *Fig 83, Page 34*
44. **Repair:** The sliding screen door is damaged and should be repaired as necessary. *Page 34*

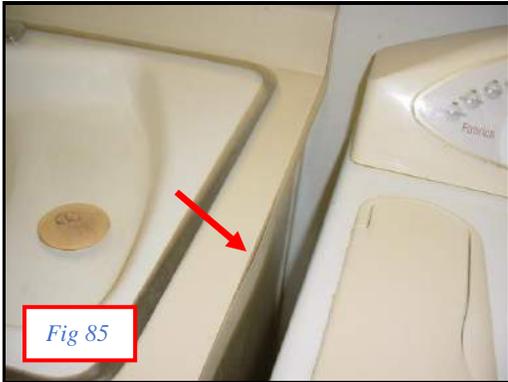
Fig 85

45. **Repair:** The countertop veneer is loose in the kitchen and laundry room and should be secured as necessary. *Fig 85, Fig 86, Page 34*
46. **Repair:** Missing drawer fronts in the laundry room should be replaced as necessary. *Fig 87, Page 34*

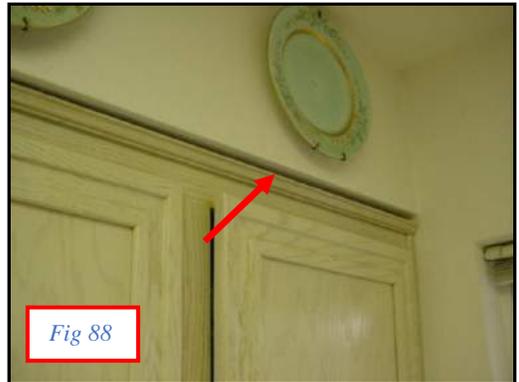
Fig 88

47. **Repair:** The upper cabinets in the kitchen are loose and could fall. Improvements are needed to help prevent damage and or injury. *Fig 88, Page 34*

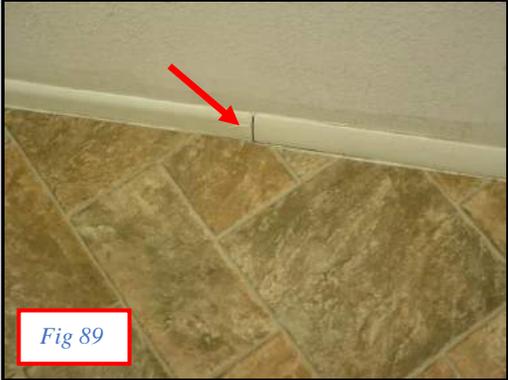
- **Repair:** The upper cabinets in the kitchen are loose and could fall. Improvements are needed to help prevent damage and or injury. *Fig 88*
- **Repair:** Caulking and painting improvements are recommended to the interior trim. *Fig 89*
